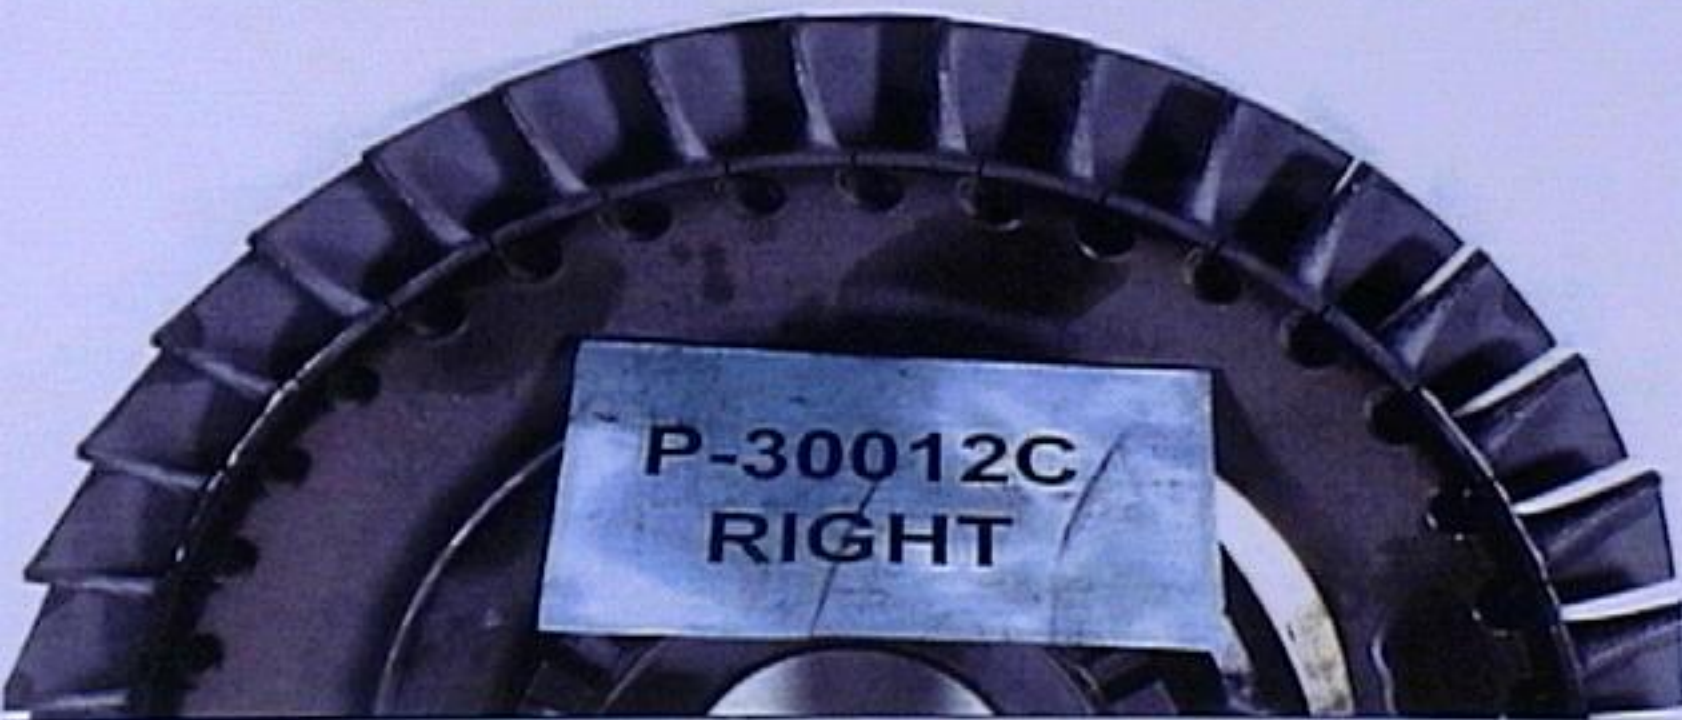
**Figure 123. Metal Spray Deposits on the First-Stage Turbine Blades**
